REPORT OF INSPECTION PROCEDURES AND RESULTS  
FOR  
DETERMINING QUALIFICATIONS  
OF A  
TAX INCREMENT FINANCING DISTRICT

ST JOE'S HOSPITAL  
REDEVELOPMENT TIF DISTRICT

SAINT PAUL PORT AUTHORITY  
SAINT PAUL, MINNESOTA  
NOVEMBER 14, 2025

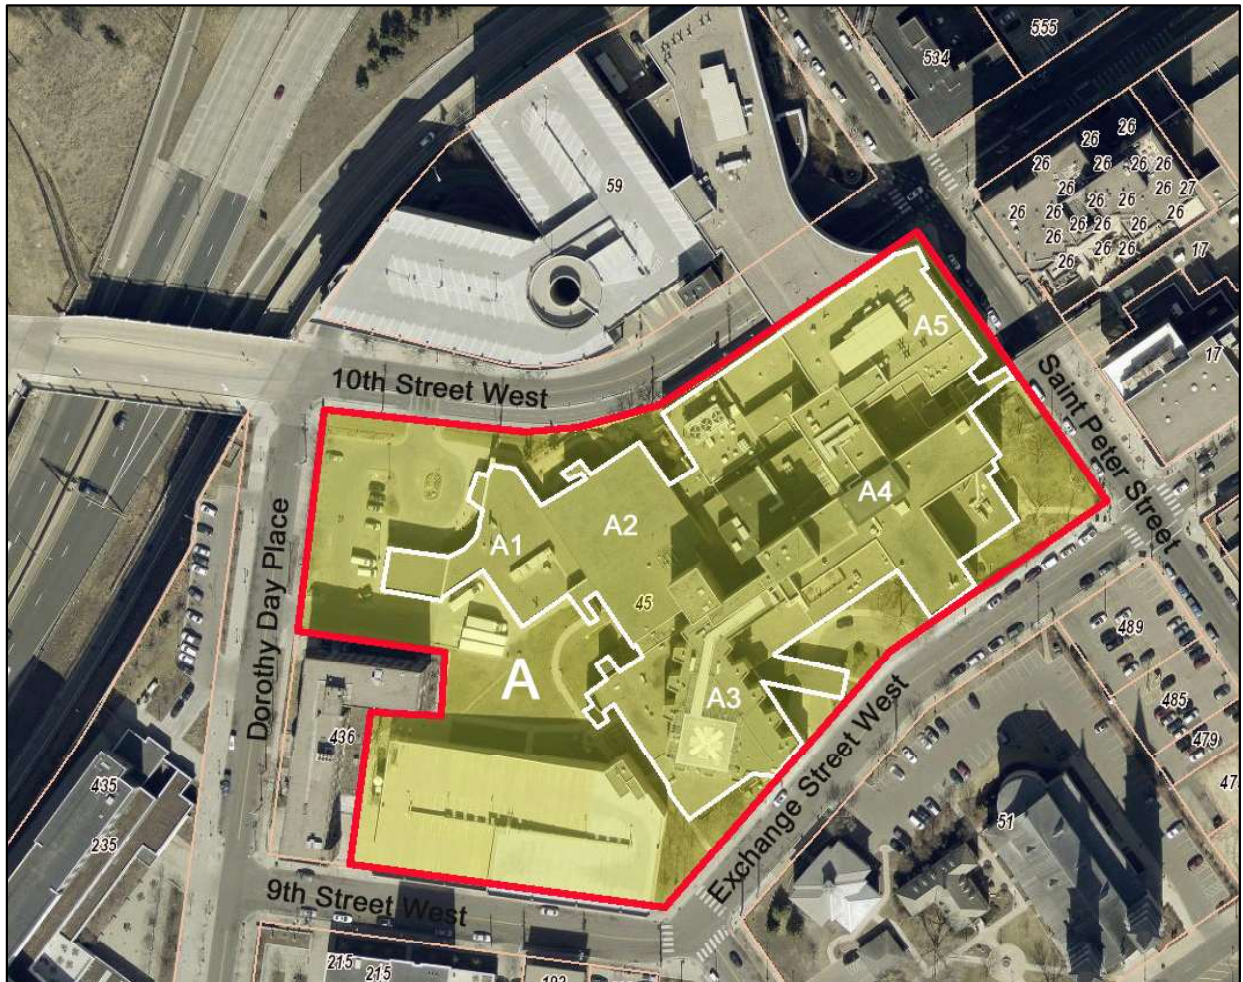
**Diagram 2 – Coverage Diagram**

The proposed TIF District met the coverage test under *Minnesota Statutes, Section 469.174, Subdivision 10(e)*, which resulted in parcels consisting of 100 percent of the area of the proposed TIF District being occupied by buildings, streets, utilities, paved or gravel parking lots, or other similar structures (Diagram 2). This exceeds the 70 percent area coverage requirement for the proposed TIF District under *Minnesota Statutes, Section 469.174, Subdivision (a) (1)*.

Shaded area depicts a parcel more than 15 percent occupied by buildings, streets, utilities, paved or gravel parking lots or other similar structures

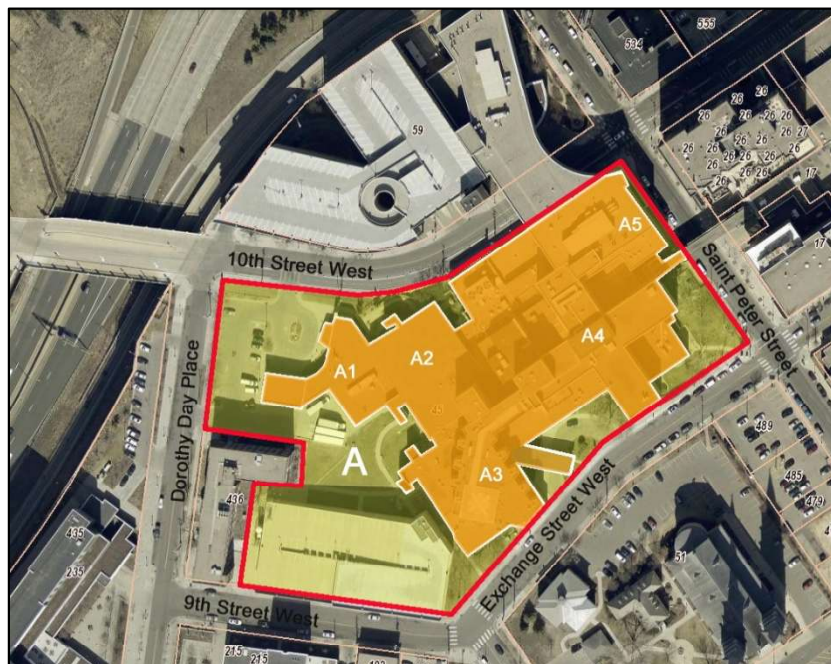
**Diagram 3 – Substandard Buildings**

The parcels with substandard buildings are reasonably distributed compared to all parcels that contain buildings.

Shaded yellow area depicts parcels with buildings.  
Shaded orange area depicts substandard buildings.
