## INSPECTION REPORT – LICENSING

Business/DBA Name: The Commodore

Business Address: 79 Western Avenue North, Saint Paul, MN 55012

Reason for Inspection: Referral from Legislative Hearing Office

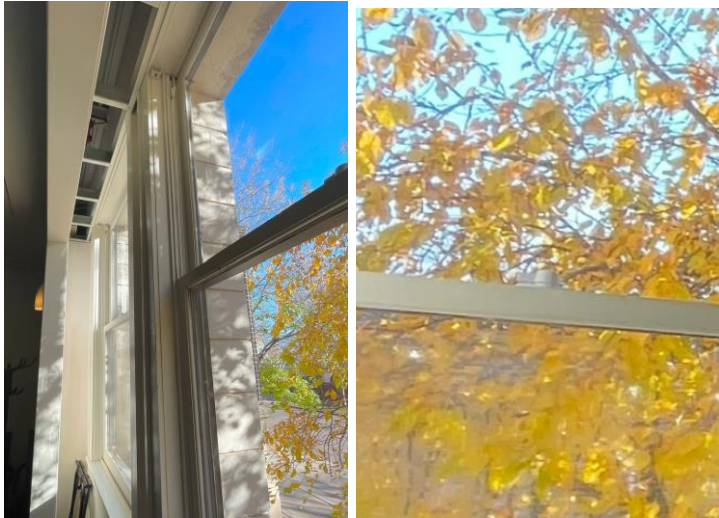
#### **Condition #2:**

#### **Inspection Result: Non-Complaint and Compliant**

**Inspector Observations:** Only primary windows were installed – no secondary “storm windows” existed. The windows appeared to be relatively new, in good condition and were equipped with locking mechanisms that prohibit opening without a key. This condition was imposed more than six months ago.

**Summary of Mr. Rupp's comments:** Locks have been installed, storm windows not needed based upon previous professional noise testing results.

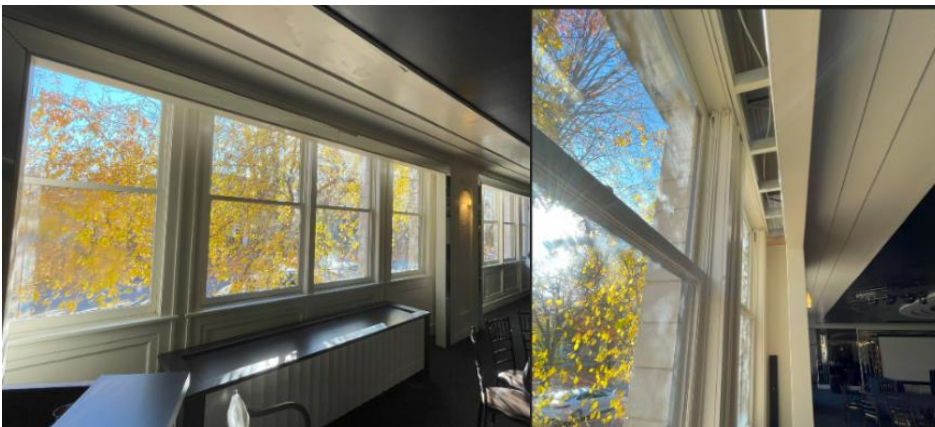
**Condition #3:**

**Inspection Result: Non-Compliant**

**Inspector Observations:** Windows were not equipped with drapes, shades, blinds, or any other type of window treatment. This condition was imposed more than six months ago.

**Summary of Mr. Rupp’s Comments:** Drapes not needed; cost \$30,000. No complaints of sound or light. If ever a complaint about light the Commodore would install blackout shades. Suggested this condition be changed to require compliance with Noise ordinance and if complaints are made, allow the Commodore to determine how to mitigate light and/or noise.

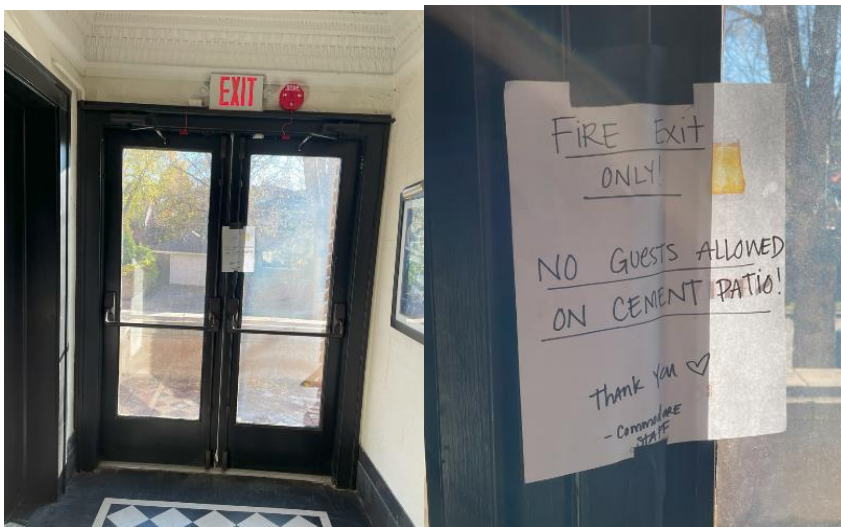
**Condition #4:**

**Inspection Result: Compliant**

**Inspector Observation:** South (Holly Avenue) door was equipped with crash bar and sounding device to alarm when opened. Basic hand-written sign posted noting door as a “Fire Exit Only”.

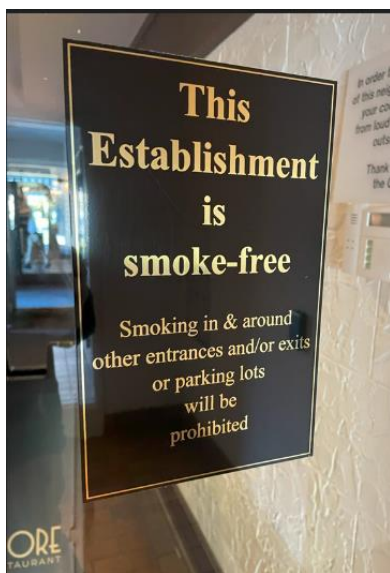
**Condition #10:**

**Inspection Result: Non-Compliant and Compliant**

**Inspector Observation:** Mr. Rupp was asked where the designated smoking area was and responded it was not necessary as the entire establishment is smoke free. No designated smoking area was determined to exist. Two (2) sizable signs were prominently displayed on each side of the main entrance to the establishment reading, "This Establishment is smoke-free Smoking in & around other entrances and/or exits or parking lots will be prohibited"

**Summary of Mr. Rupp's comments:** Mr. Rupp explained that smoking was not allowed in or near the premises and customers who ask to smoke are directed by staff to do so on a public sidewalk.

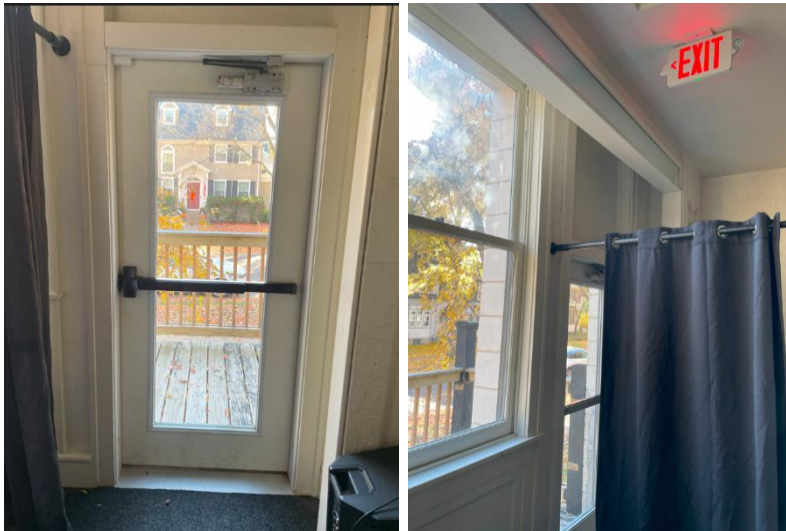
**Additional Observation:** A second door allowing access to Holly Avenue is located on the western-most side of the ballroom left of the stage that is not equipped with an alarm or designated as an emergency/fire exit. This door was apparently not part of the originally licensed premises and therefore not included in the original conditions to be designated as an alarmed emergency exit:
