On behalf of nineteen residents, please see the attached letter to City Council regarding the proposed Mill & Overlay assessment for Montrose Lane.

We are writing to protest and object to the proposed assessment for a Mill and Overlay of Montrose Lane. Certain aspects of this proposal have raised concerns regarding Council oversight of the City of St. Paul Public Works and St. Paul Regional Water Services (SPRWS). The following facts clarify our concerns:

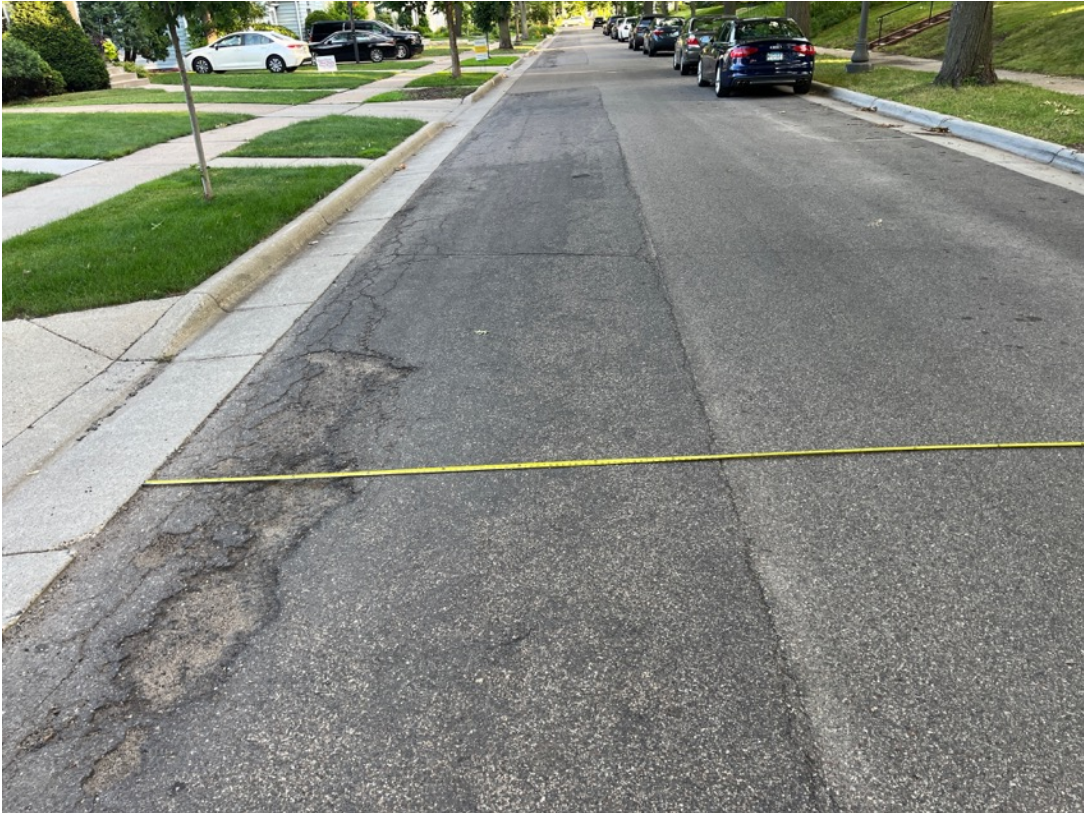
**1) View looking south at unreconstructed east lane of pavement (the driving lane), which is full of potholes. Full-width reconstruction is visible at each manhole.**

- In 2018, SPRWS replaced water services on Montrose Lane. SPRWS conducted a full-depth reconstruction of a portion of the bituminous roadway section, spanning 12'4". Additionally, some areas underwent full-width reconstruction for manhole access. It is estimated that only 30% (~7,700 sf) of the road was not reconstructed (please see photos on Pages 3 and 4 of this letter).

- The unreconstructed pavement is now deteriorating due to age, excess use by construction equipment from 2018, and increased traffic flow resulting from recent City parking restrictions.

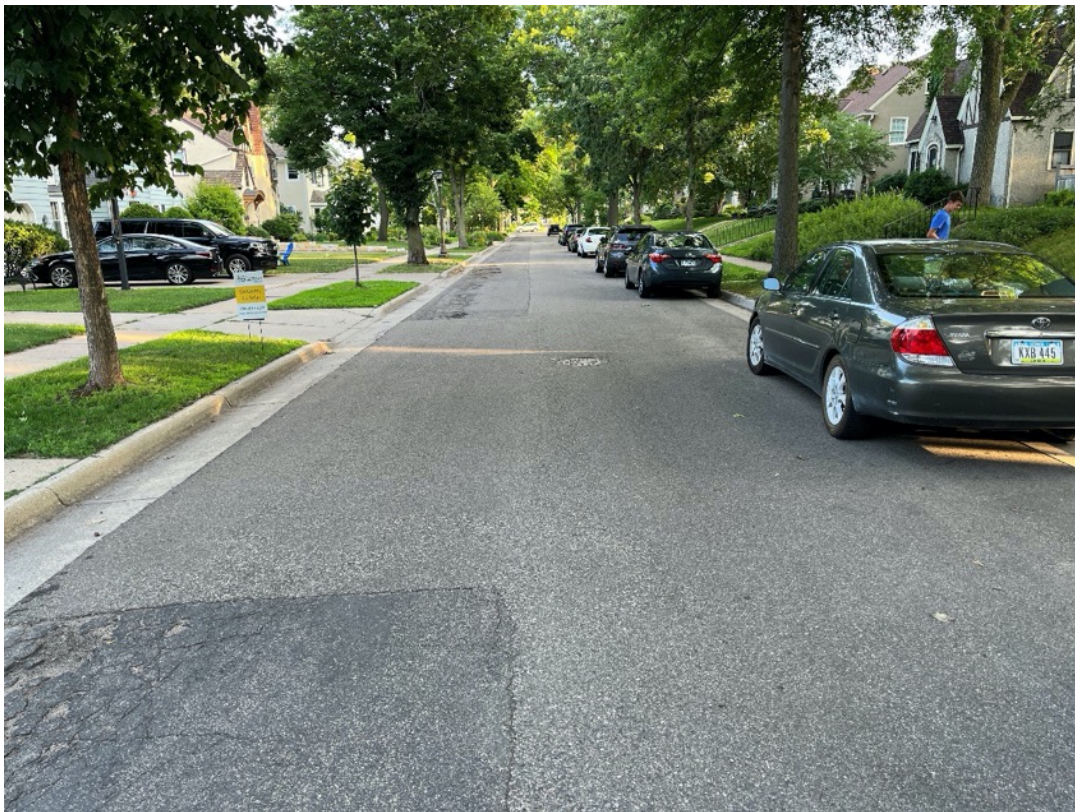
**2) View looking south at fully reconstructed pavement around manhole in excellent condition, preceded and followed by unreconstructed pavement in poor condition.**

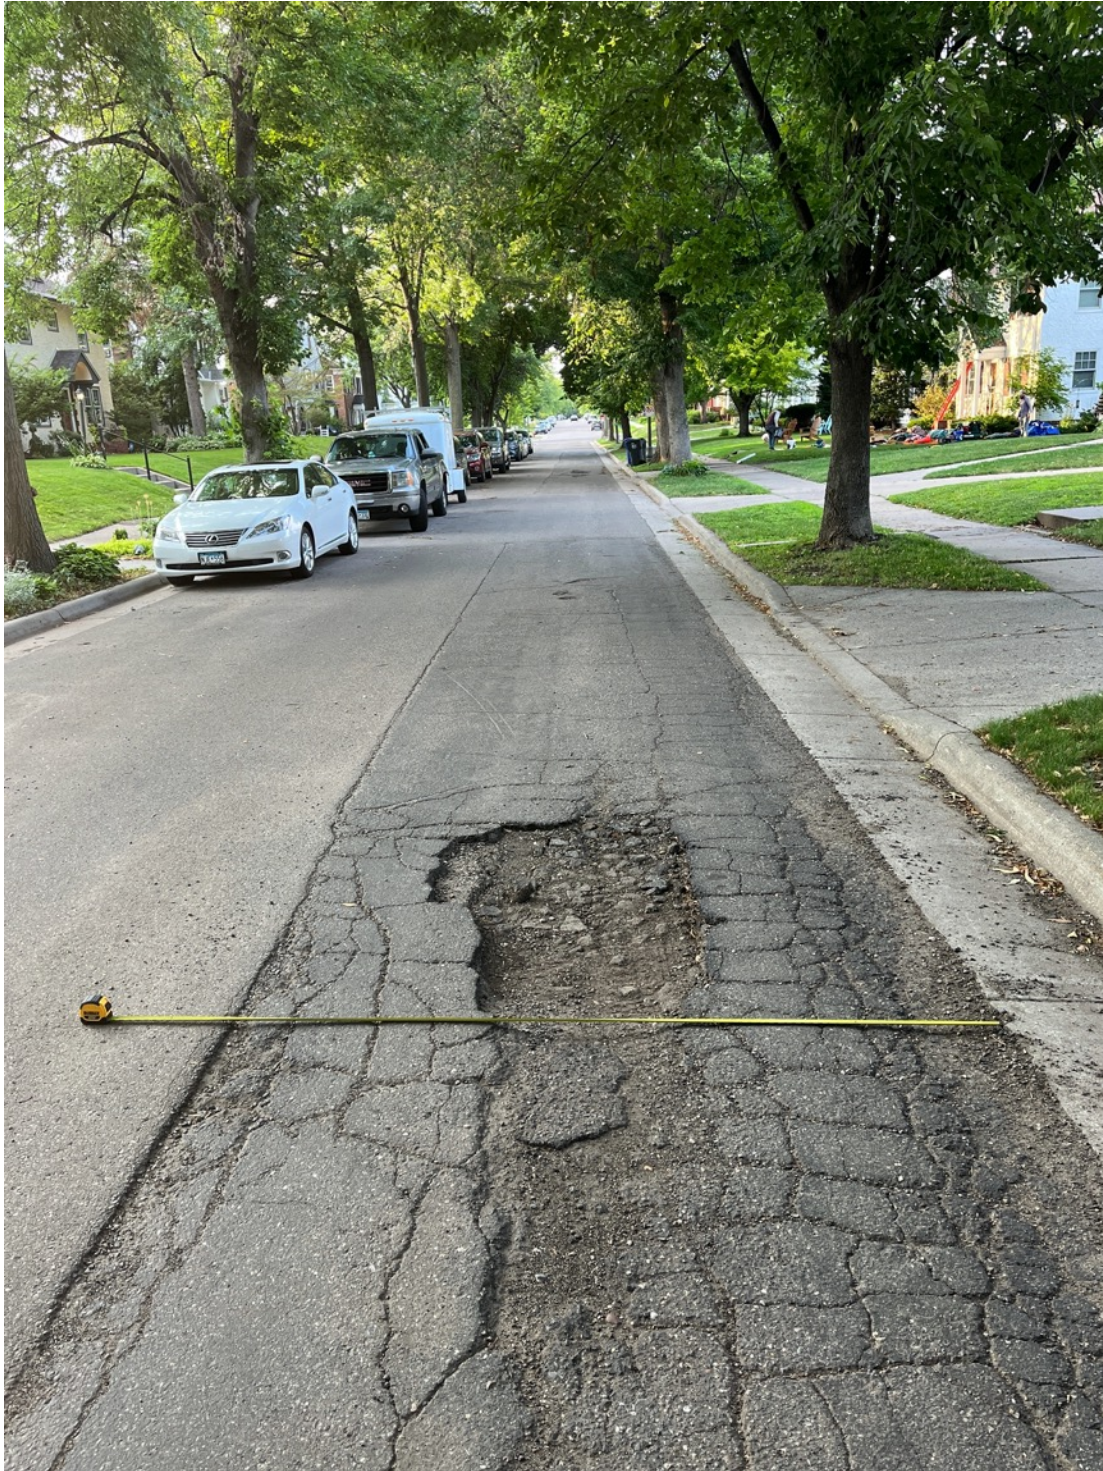
**3) View looking north at unreconstructed east lane of pavement (the driving lane due to parking restrictions), which is full of potholes. Full-width reconstruction is visible at each manhole.**
