From: Richard Kedrowski
Sent: Tuesday, April 22, 2025 11:58 AM
To: Mai Vang
Cc: Marcia Moermond; Joanna Zimny; Lisa Martin
Subject: 2002 James Ave. garage

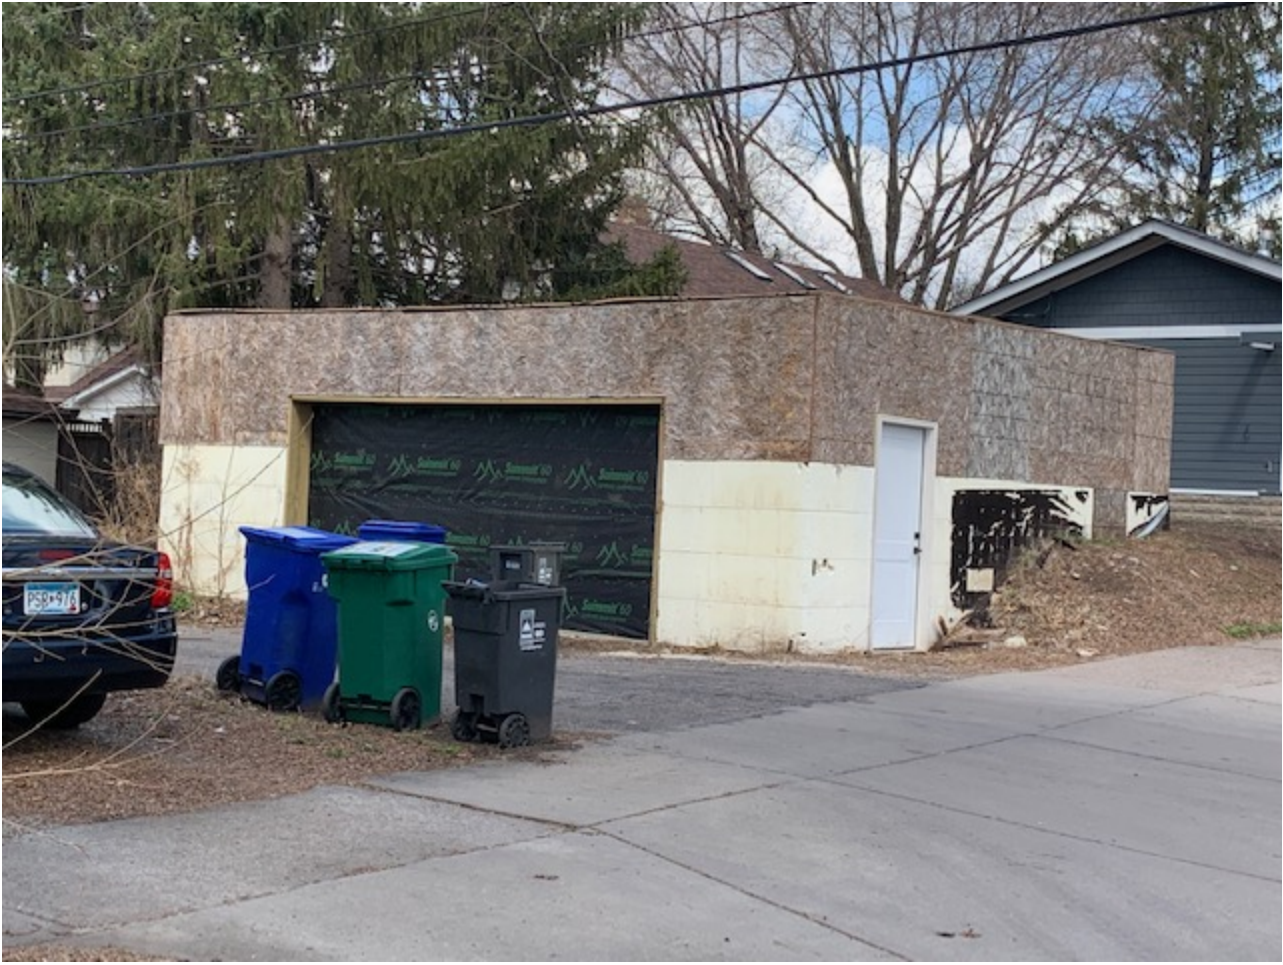
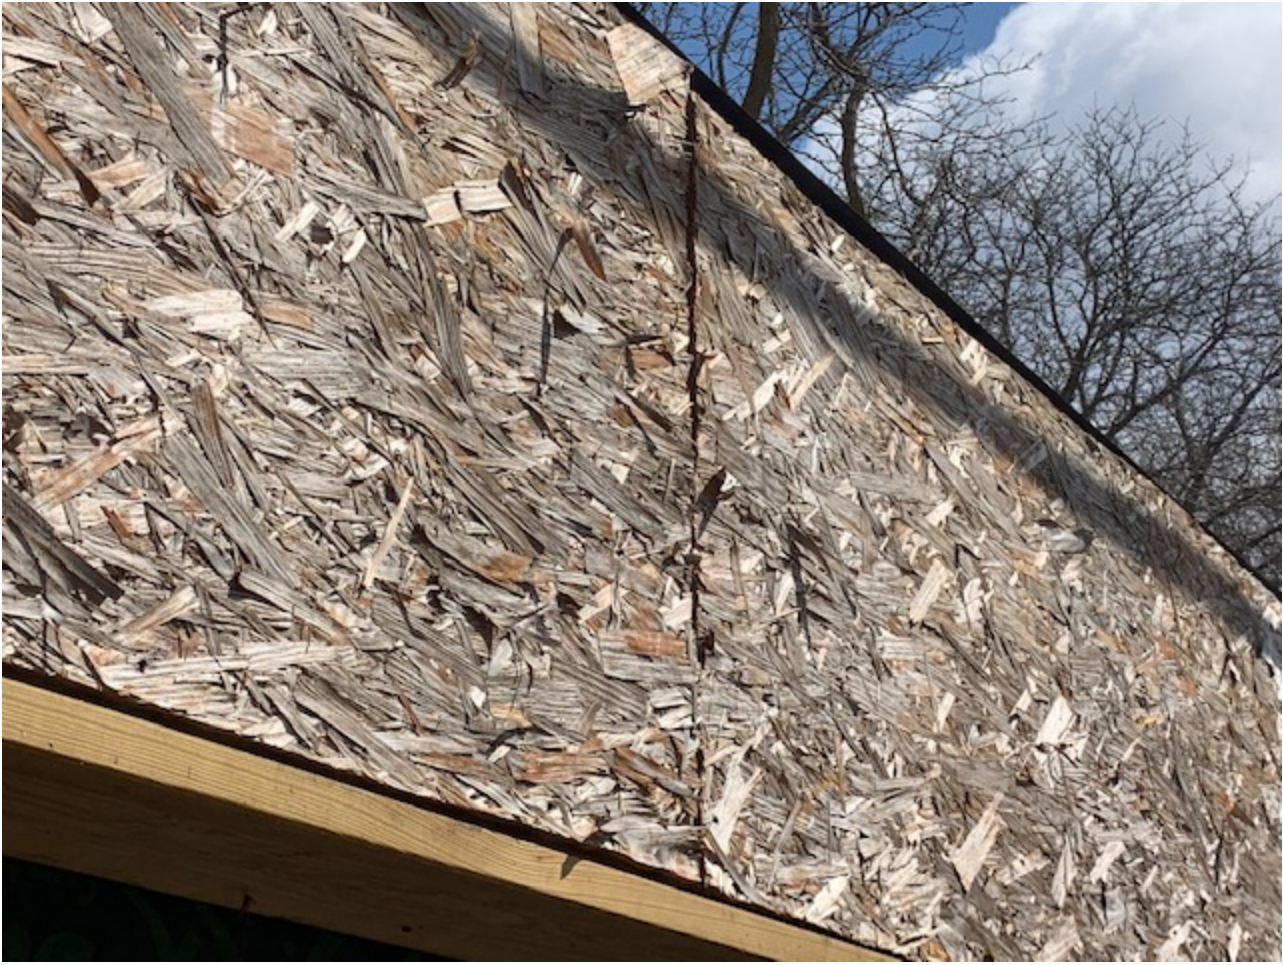
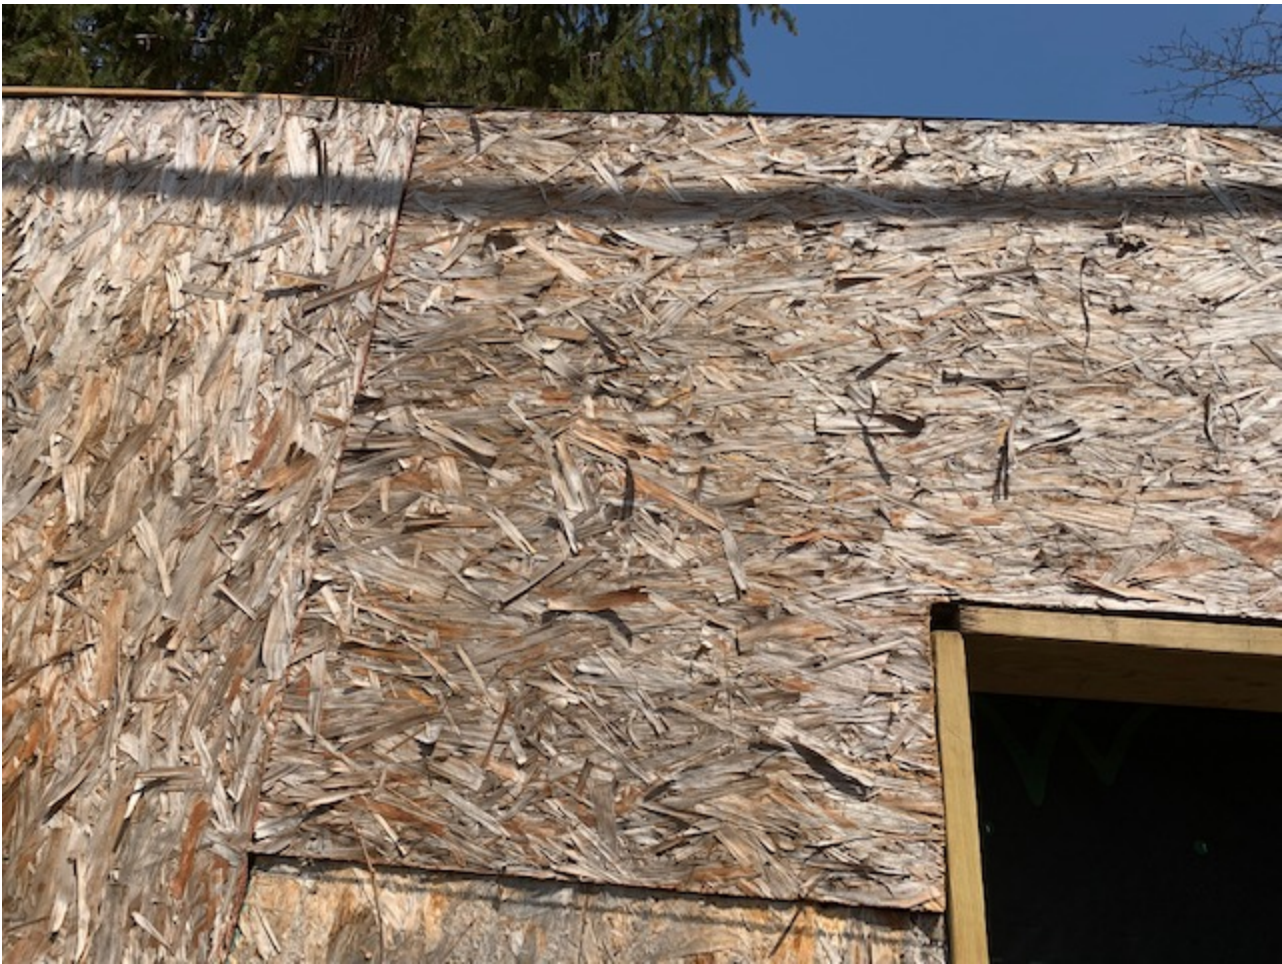
Service door is installed. Overhead door is plywood covered in roofing felt. No roof and no siding. OSB sheathing is severely delaminating. Nathan Bruhn had expressed to me that the sheathing once exposed to the elements for approximately three months will lose its structural integrity. Much of that sheathing will need to be replaced.
